UUID
41cabf0b-213c-452c-b9f0-9a434dc5c234

Date
2023-05-09 09:17:53

VIN
Make
VW
Model

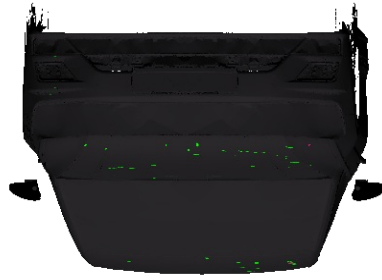
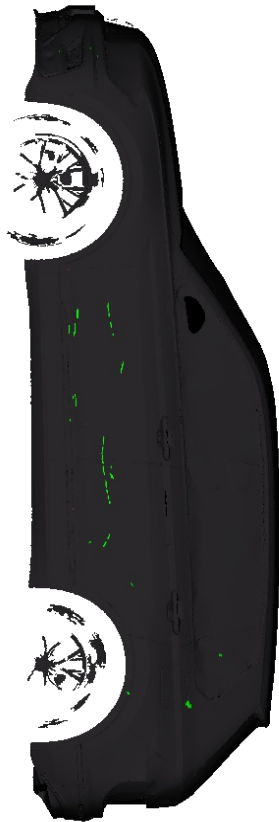
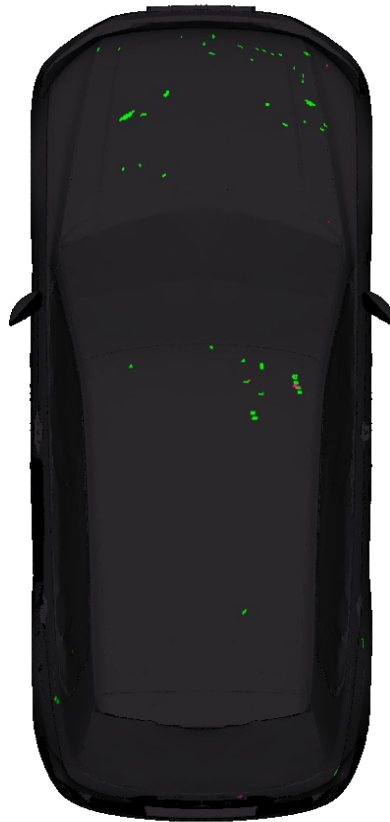
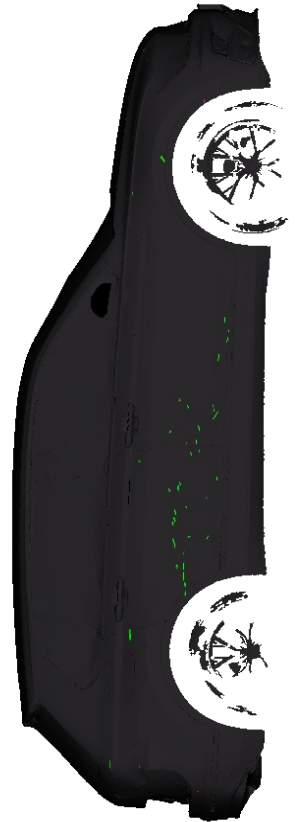
Part size[mm]	Dent						Scratch						CoatingDamage					
	<10	<20	<30	<50	>50	Σ	<10	<20	<30	<50	>50	Σ	<10	<20	<30	<50	>50	Σ
Trunk lid	0	0	2	0	0	2	0	0	1	0	0	1	0	0	0	0	0	0
unknown partID 6750105	0	0	0	0	0	0	0	0	0	0	1	1	0	0	0	0	0	0
unknown partID 16764057	0	0	0	0	0	0	0	1	0	0	0	1	0	0	0	0	0	0
Roof	0	0	0	1	0	1	0	4	8	2	0	14	1	0	0	0	0	1
Hood	1	1	0	0	0	2	0	14	7	6	2	29	0	0	0	0	0	0
Bumper rear	0	1	0	0	0	1	0	1	0	0	2	3	0	1	0	0	0	1
Side panel right	0	0	0	0	0	0	0	0	0	0	1	1	0	0	0	0	0	0
Bumper front	1	0	0	0	0	1	0	4	1	0	0	5	0	0	0	0	0	0
Side panel left	0	0	0	0	0	0	0	1	0	0	0	1	0	0	0	0	0	0
Door front left	1	0	0	0	0	1	0	5	1	4	4	14	1	0	0	0	0	1
Door rear left	0	0	0	0	0	0	0	6	3	4	2	15	1	0	0	0	0	1
Door rear right	0	0	0	0	0	0	0	8	6	4	1	19	0	0	0	0	0	0
Door front right	0	0	0	0	0	0	0	8	5	2	1	16	4	0	0	0	0	4
Fender front right	0	0	0	0	0	0	0	0	1	0	0	1	0	0	0	0	0	0

part	reason	action	cost
Bumper front	small dents, scratch	Smart Repair	195.0
Door front left	coating damage, scratch	Smart Repair	250.0
Door front right	large number of scratches, many small scratches	Repair Part	419.2
Door back left	coating damage, scratch	Smart Repair	400.0
Door back right	scratch	Smart Repair	150.0
Side body right	scratch	Smart Repair	50.0
Roof	coating damage	Smart Repair	50.0
Roof rail left	scratch	Smart Repair	50.0
Trunk/Trunklid	dents	Repair Part	419.2
sum			1983.4
fe160fcc03a29a4c34b1a68bb2aa84ac8d7f28fa1365c6dcbf736c0058d1b9bf
